2001 BUILDING FAILURES STUDY

Introduction

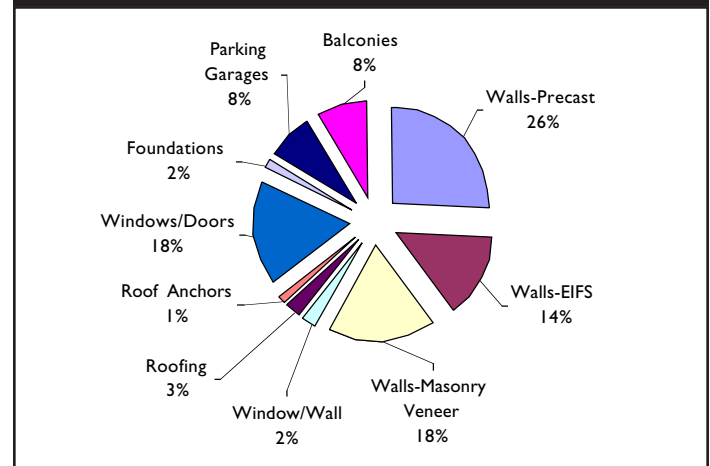
Figure 2. Frequency and cost of deficiencies

Using these adjustments, the relative frequency and cost of deficiencies for 10 common building components were determined, as shown in **Figure 2**.
